REGIONAL SCHOOL DISTRICT 17

EDUCATIONAL FACILITIES ASSESSMENT

November 2021

Report Prepared By Tecton Architects
34 Sequassen Street, Suite 200, Hartford, CT, 06106

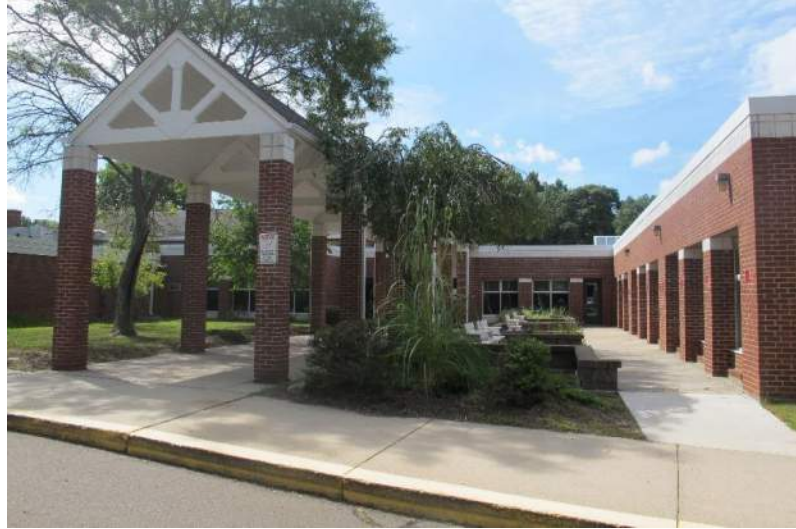
D.3.3: Walkways

- Paved play areas show signs of deterioration
- Repair bituminous walks within courtyard.

- Full depth replacement of curbs and sidewalks.
- Install new ADA and IBC compliant concrete stairs and railings.
- Full depth replacement of parking lots and driveways.

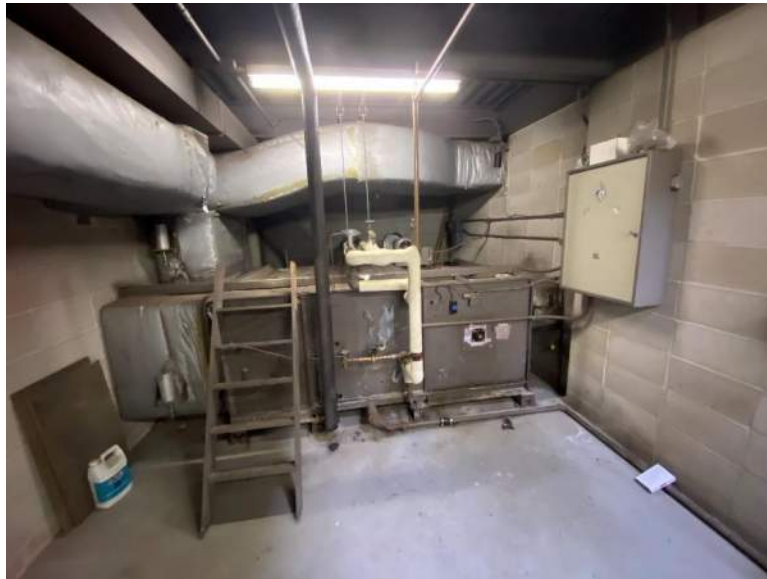
Indoor Air Handling Units

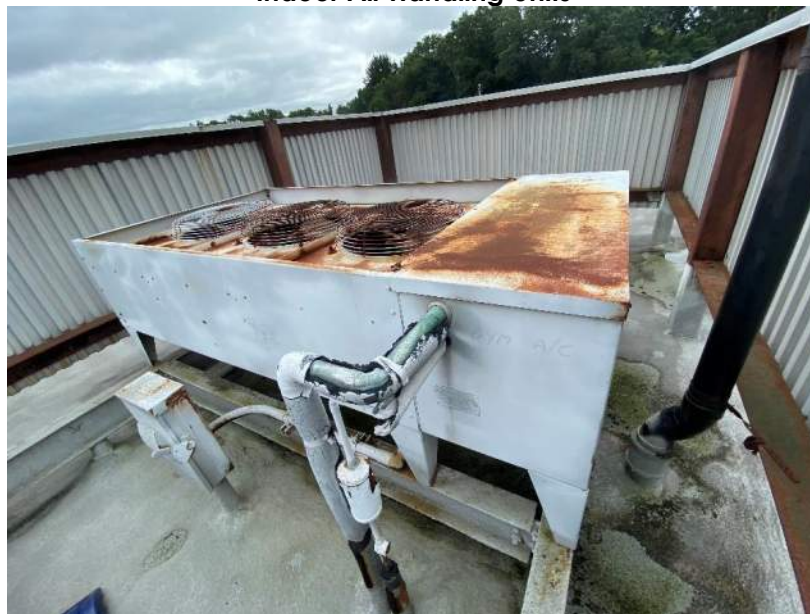
Associated outdoor condensing unit
