REGIONAL SCHOOL DISTRICT 17

EDUCATIONAL FACILITIES ASSESSMENT

November 2021

Report Prepared By Tecton Architects
34 Sequassen Street, Suite 200, Hartford, CT, 06106

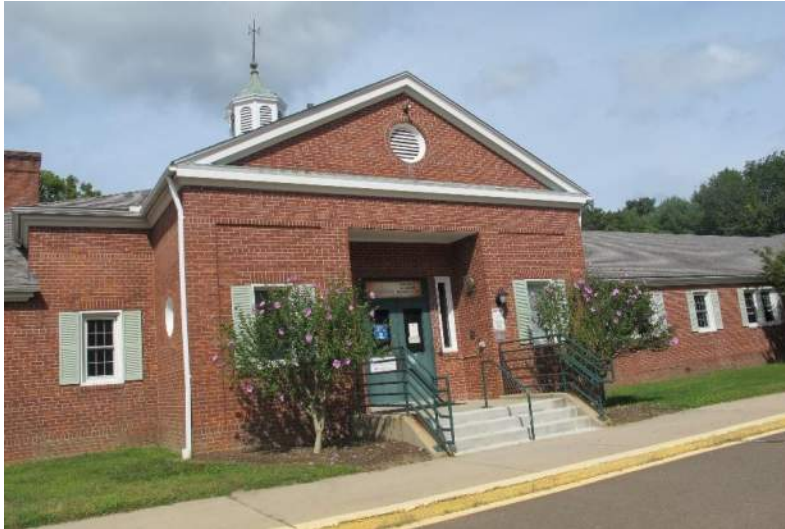
D.1.3: Exterior – Main Entrance

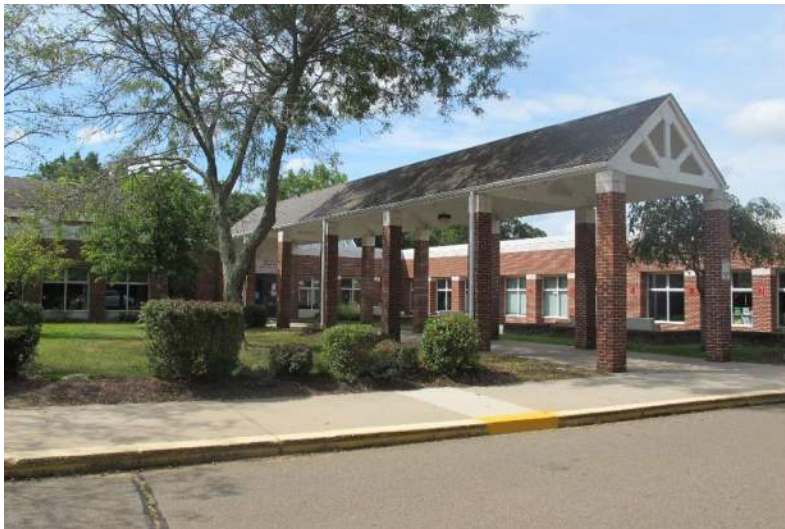
D.1.4: Exterior – Secondary Entrance

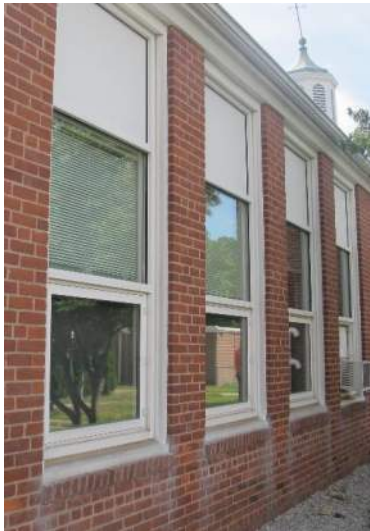
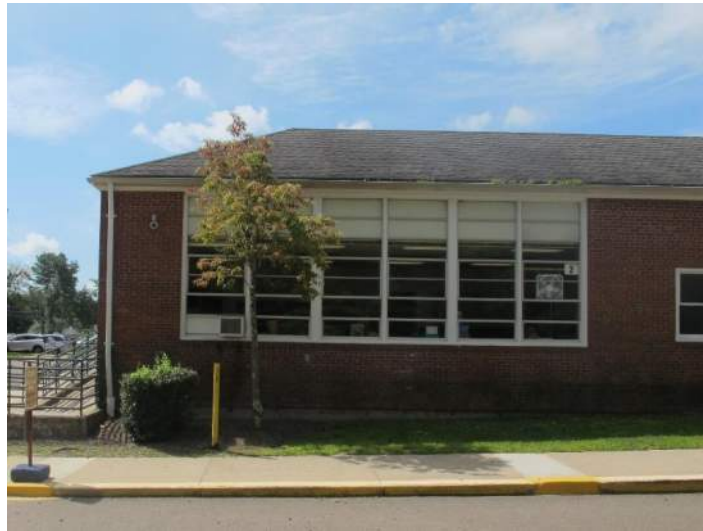
D.1.7: Exterior – Walls & Windows – Vintage 1

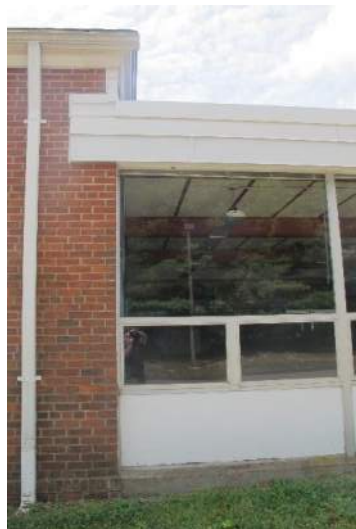
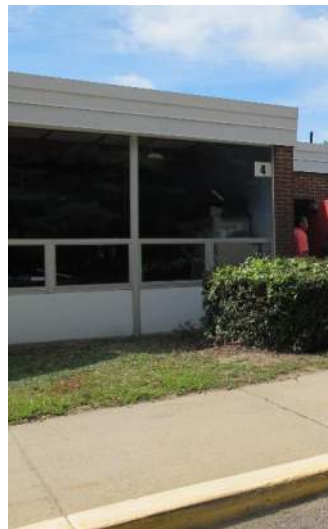
D.1.8: Exterior – Walls & Windows – Vintage 2

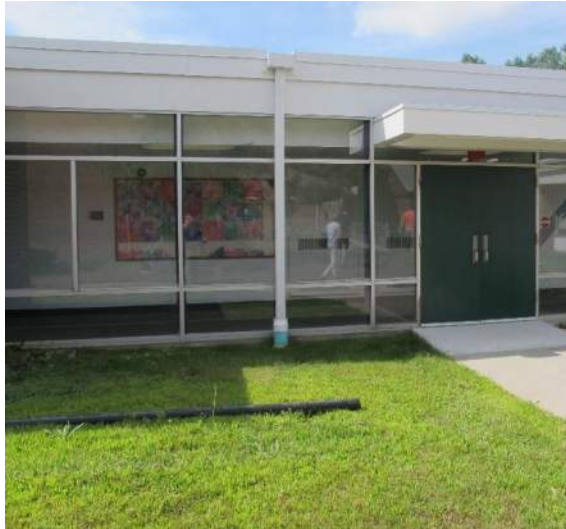
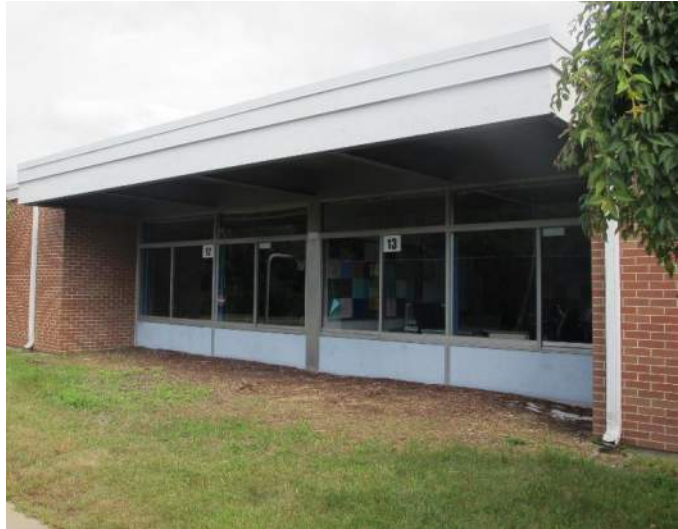
D.1.9: Exterior – Walls & Windows – Vintage 3

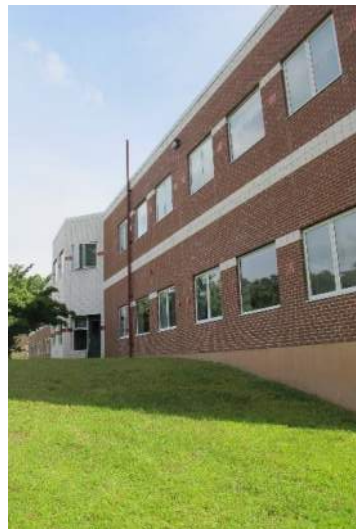
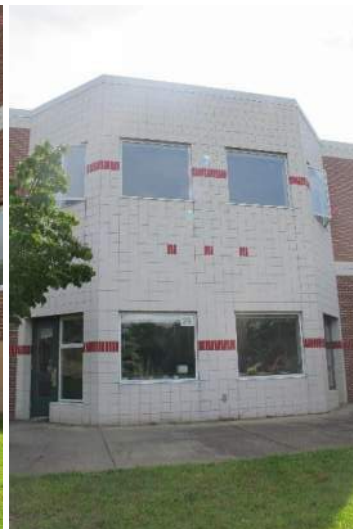
D.1.10: Exterior – Walls & Windows – Vintage 4

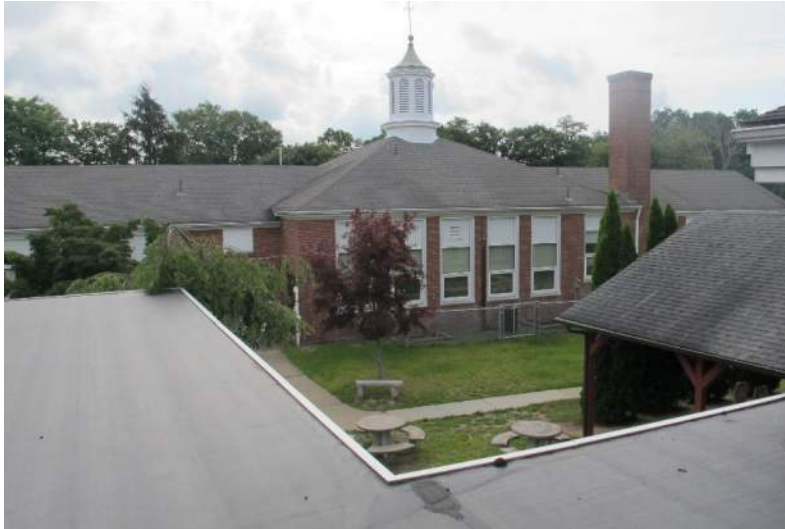
D.1.11: Roof – Architectural Shingles – Vintage 1

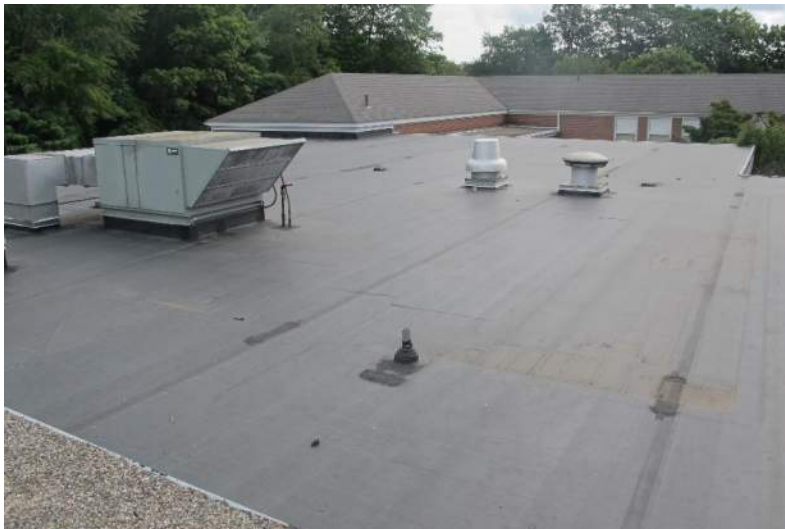
D.1.12: Roof – EPDM Membrane – Vintage 2

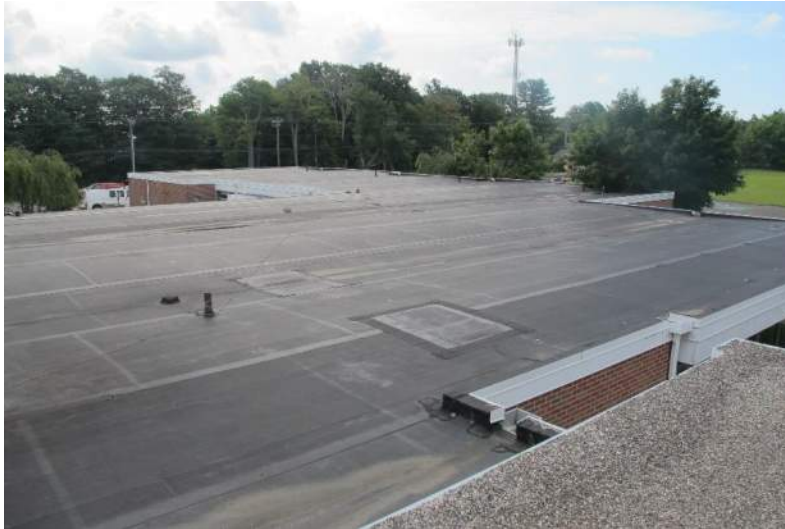
D.1.13: Roof – EPDM Membrane – Vintage 3

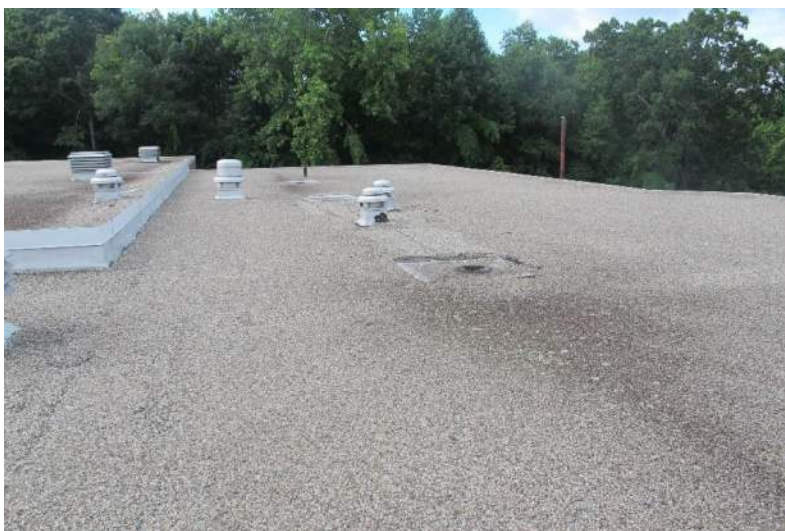
D.1.14: Roof – Gravel Built-Up – Vintage 4

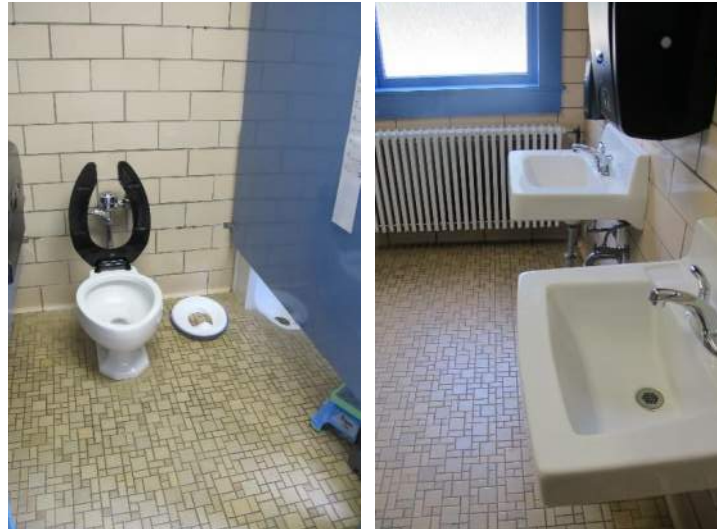
D.1.30: Interior - Toilet Facilities – Vintage 1

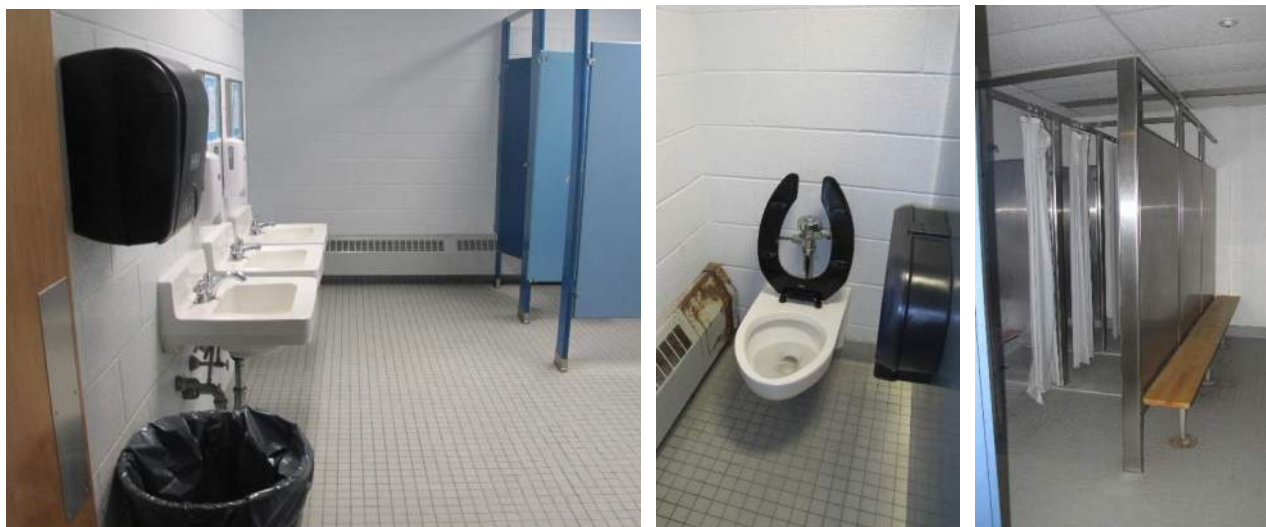
D.1.33: Interior – Toilet Facilities – Vintage 4

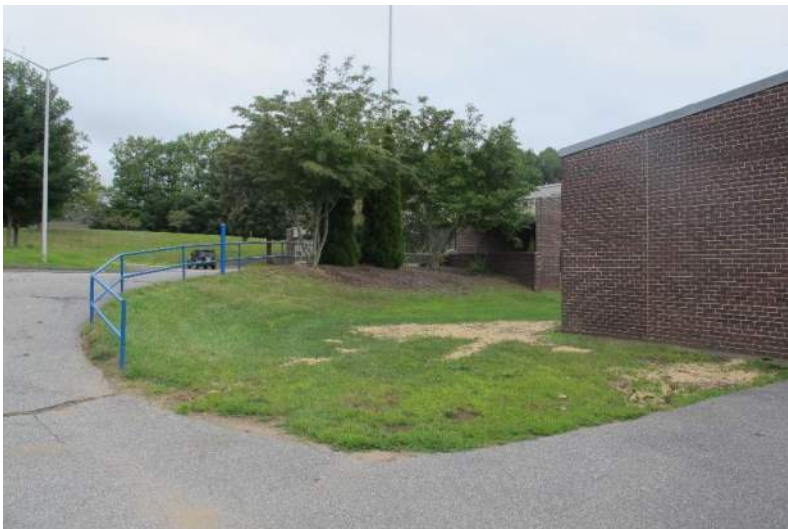
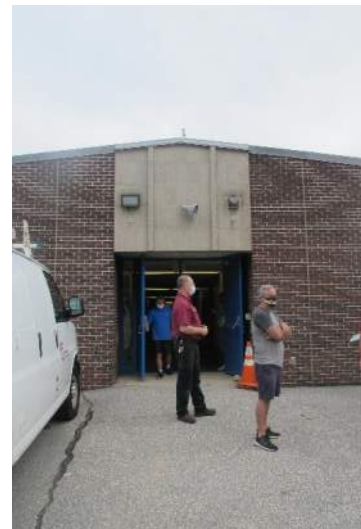
D.1.5: Exterior – Modular Units

The two "portable" classroom wings are served by a packaged roof top unit manufactured by TRANE. The TRANE Precedent units are roughly 21 years old and are in fair condition. The units are approaching the end of their useful life and should be replaced within the next 5-10 years. One of the portable classroom wings is served by a heat pump only unit while the other portable classroom wing is served by a DX packaged unit with electric resistive heat. There are (5) indoor air handling units that provide heating, cooling and ventilation to the larger group areas of the building. These areas are the library, music room, auditorium/ café, gym and admin area. The units are located in 2 separate mechanical penthouses inside the building envelope while the condensers for the units are located on the roof. The units appear to be original to the building and are operating past their useful life. Classroom ventilation is provided through unit vents manufactured by Nesbitt Aire. The units are provided with hot water heating coils and provide heating and ventilation only. The units appear to be original to the building and are operating past their useful life. Cooling is provided in some classrooms via residential style, window AC units.

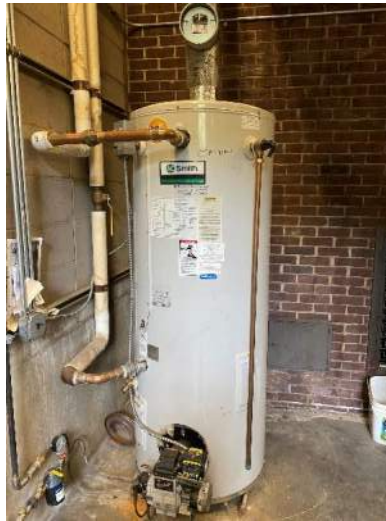
Domestic Water Heater

Domestic hot water is provided for the building via an A.O Smith oil fired water heater. The water heater is rated at 199 MBH input with 82 gallons of storage capacity. Water heater is roughly 5 years old and is in good condition.

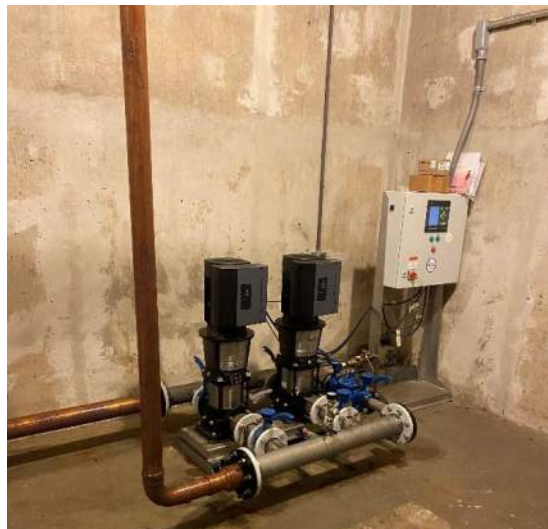
Domestic Water Booster Pumps

Domestic water for the building is provided through a private well located on site. The well pump feeds an underground storage tank, which stores the potable water used by the school. A set of duplex booster pumps manufactured by Grundfos provides water to the school from the storage tank at a pressure of roughly 60 PSI. The pumps appear to have been installed in 2018 and are in good condition. The pumps and portion of the tank are located in a lower vault in the main mechanical space. The vault is provided with a duplex sump pump along with a residential grade, cord and plug dehumidifier.

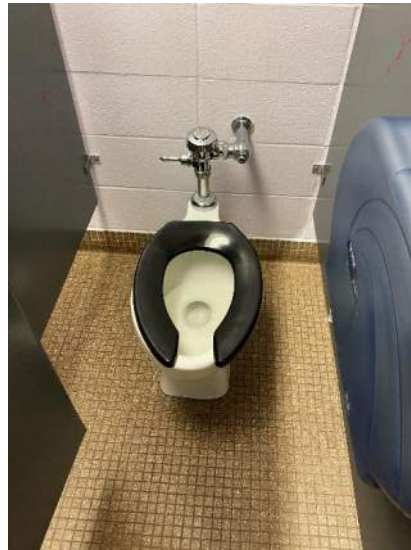
Typical Water Closet

Plumbing fixtures consist of floor mounted water closets with manual flush valves. Lavatory sinks are wall mounted with manual faucets. Fixtures appear to be in OK condition given that the fixtures appear to be original to the building.

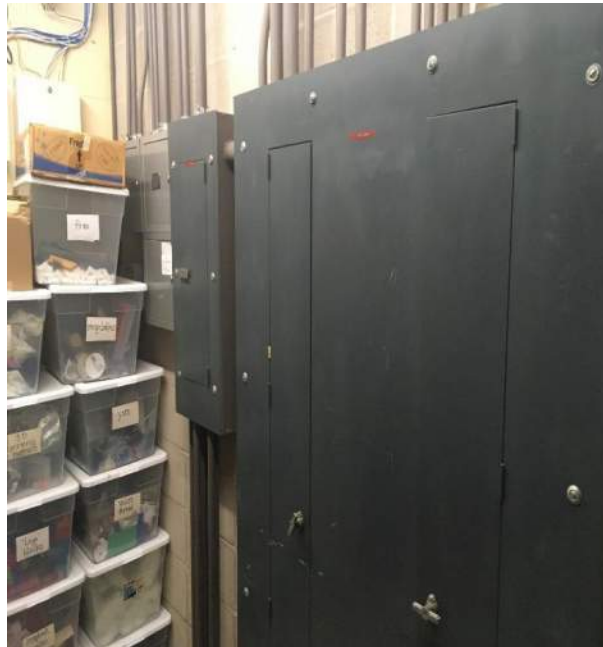
TYPICAL EXISTING PANELBOARD

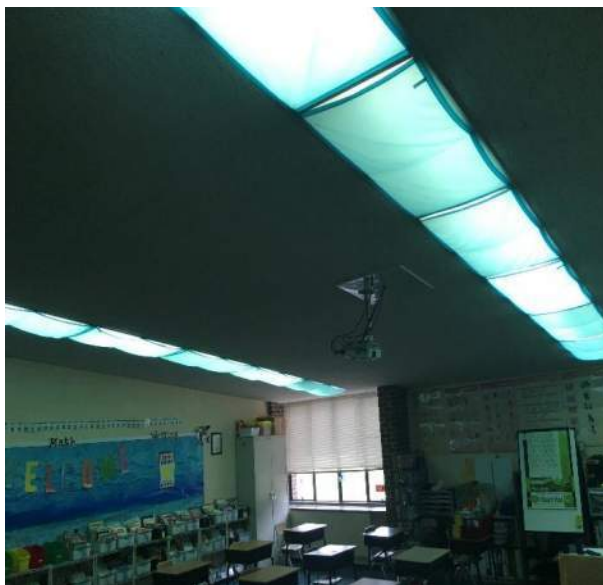
TYPICAL CLASSROOM LIGHTING

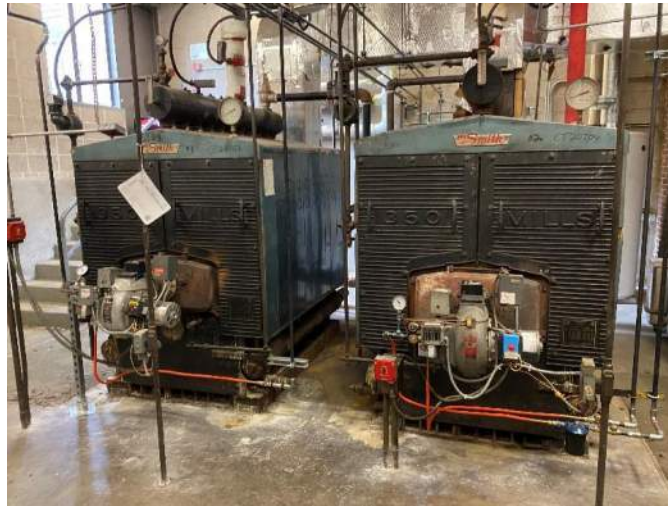
Existing Boilers

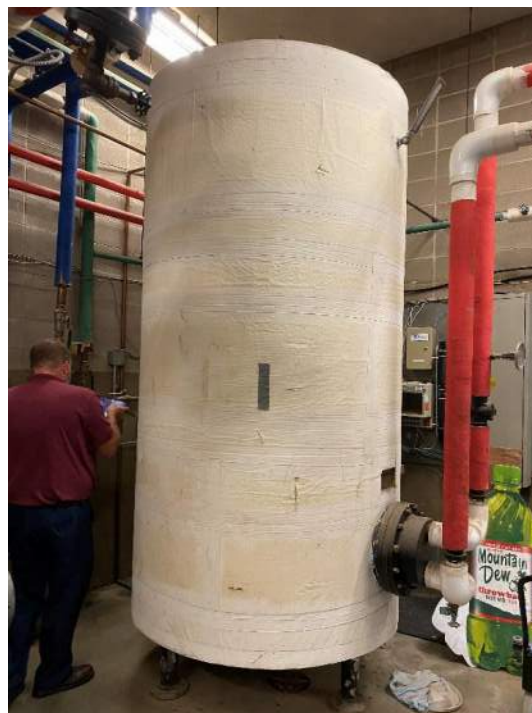
Hot Water Storage Tank

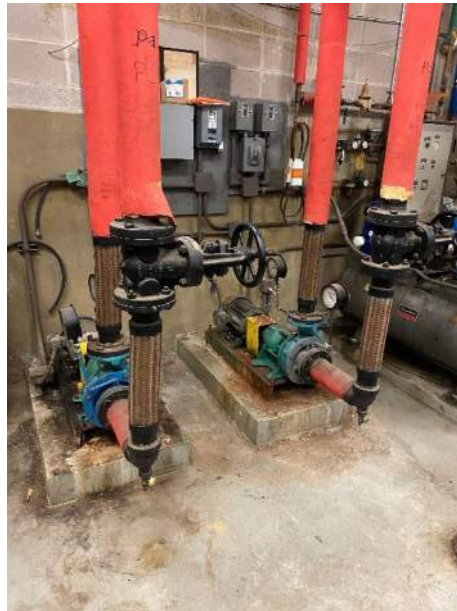
Hydronic Hot Water Pumps

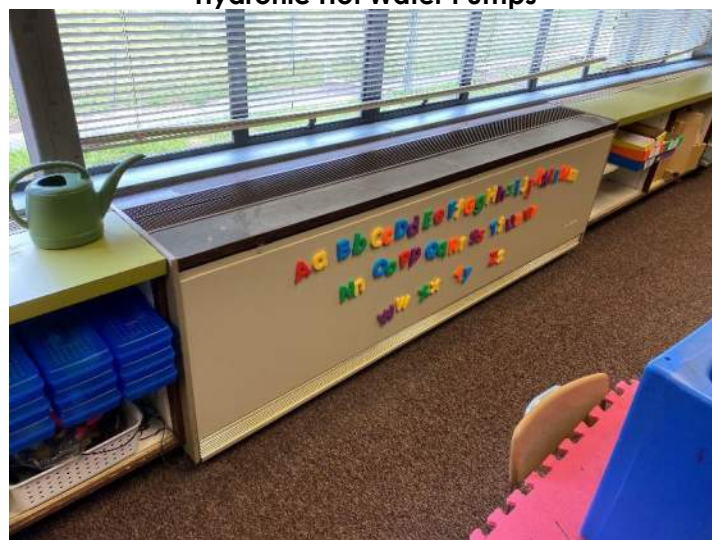
Typical Classroom Unit Ventilator

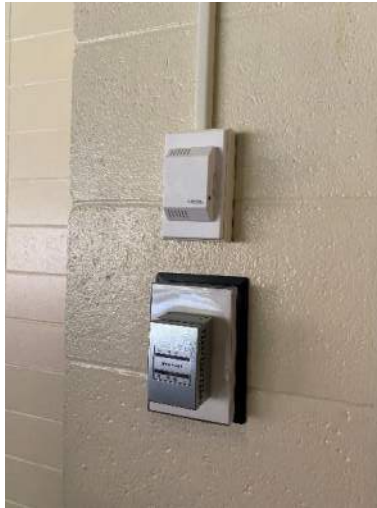
Typical Thermostat/ Sensor

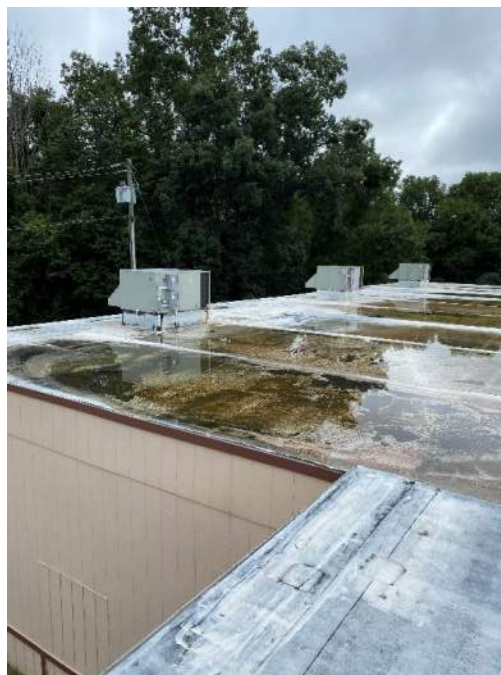
Packaged Roof Top Units

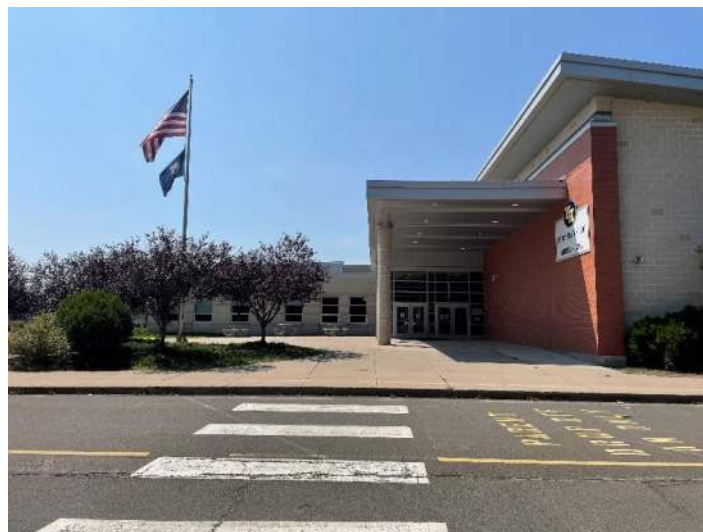
D.1.4: Exterior – Main Entry

- Fields are in very good condition but are far from the school facility.
- No ADA access to recessed courtyard
- No ADA access to main entry from bus loop

- Replace concrete stairs and paving in recessed courtyard.
- Add curb cut and ADA access at Main Entry and repair surrounding sidewalk.
- Upgrade exterior building and site lighting.

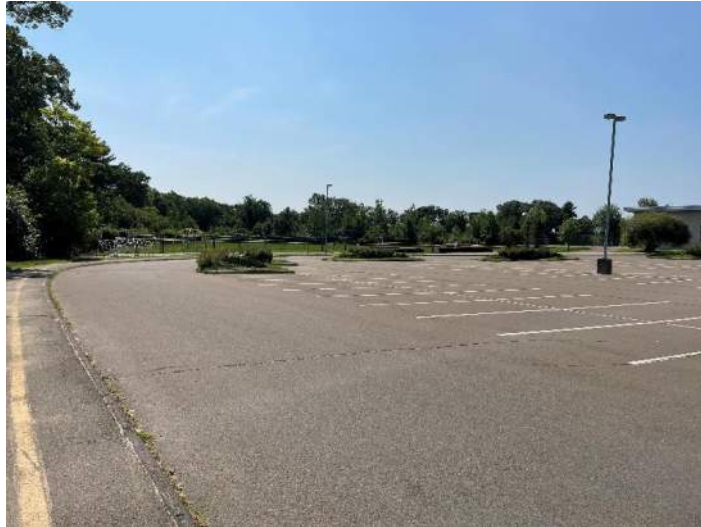
The overall condition of site pavement is fair with evidence of fine cracking and transverse cracking located throughout the drive aisles. In some areas, the bituminous pavement shows slight separation from the curb. Observation of sediment buildup is indicative of puddling along parts of the curb and stormwater infiltration into the base.

D.3.1: Driveway & Parking

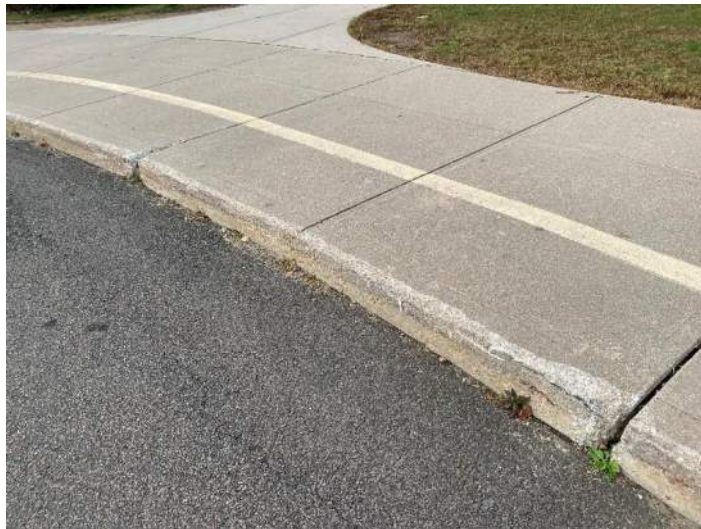
Walkways: Walkways on site consist of concrete pavement. Condition of the walkways is good. Concrete stairs and landings lead from the faculty parking area down to the courtyard between the cafeteria and gymnasium. The concrete landings show signs of deterioration and cracking from snow management.

D.3.4: Walkways

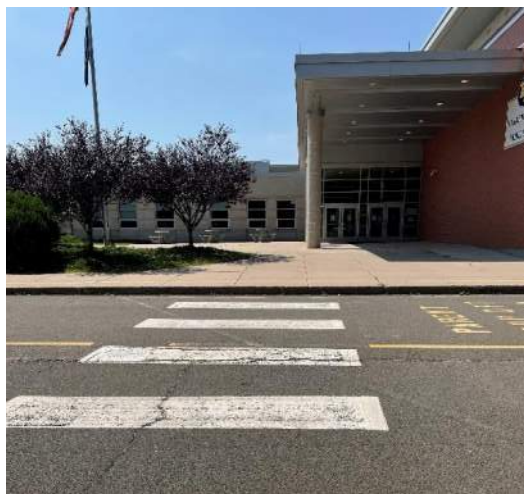
D.3.6: Main Entry – No ADA Accessibility

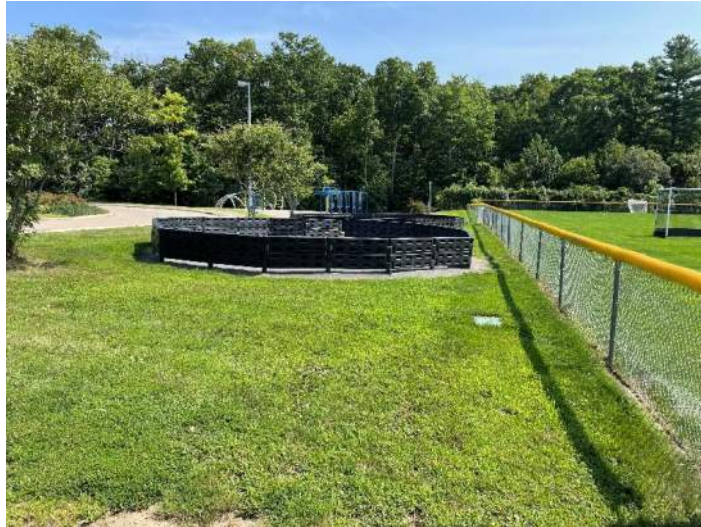
Playgrounds: A playground with raised structures is located on the east side of the site. Play equipment is dated but appears to still be in fair condition. The gravel ground cover is sufficient but could benefit from surround curbing to contain the material.

D.3.7: Play Structures

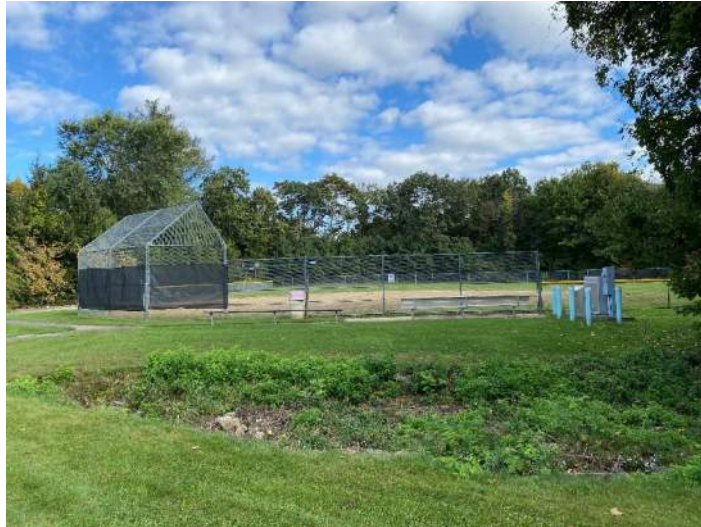
Diamond Fields: A baseball field is located along the main drive, halfway between the school facility and the main entry. A softball field is situated just off the main road, a great distance from the school. Ground cover and drainage appear to be in good condition.

D.3.11: Diamond Fields

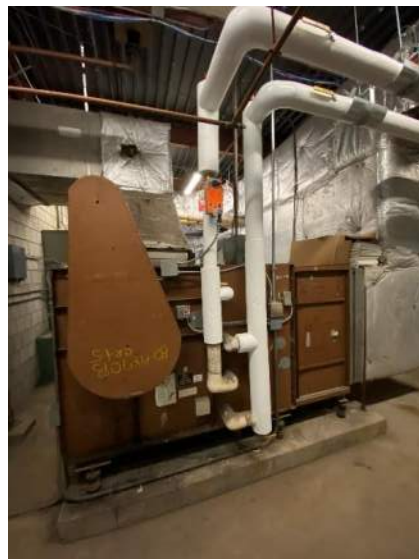
D.2.6: Air Handling Unit Serving the Pool Room

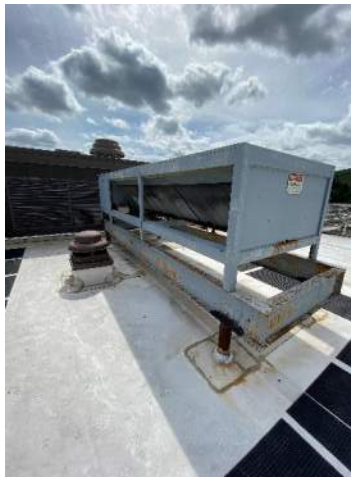
D.2.7: Condenser Unit Located Outside on the Roof

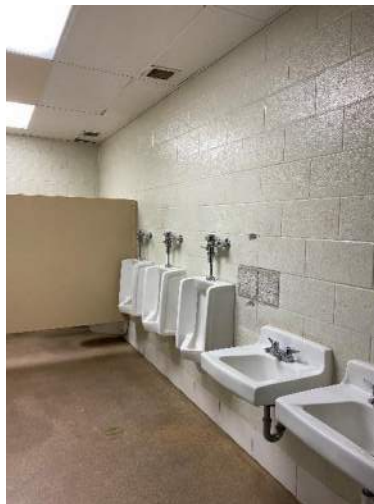
D.2.8: Manual Plumbing Fixtures

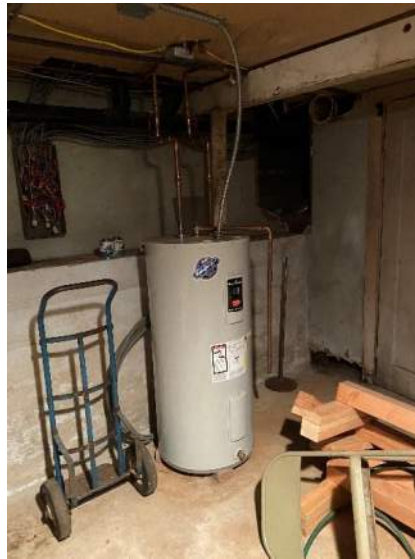
D.2.9: White House Domestic Hot Water Tank

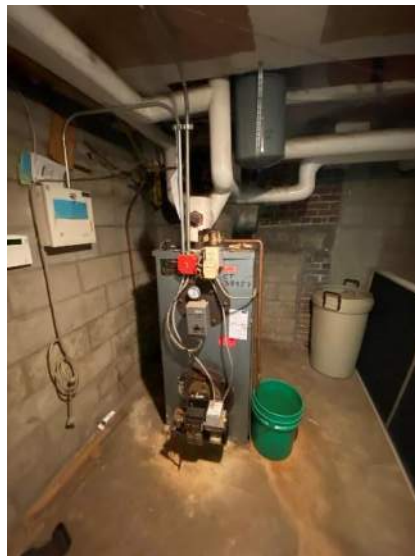
D.2.10: White House Hot Water Boiler

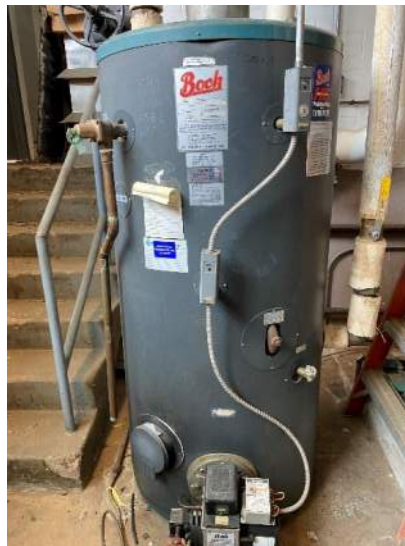
D.2.11: Central Office Building Domestic Hot Water Heater

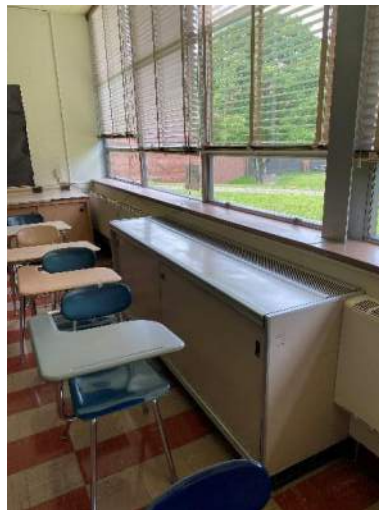
D.2.12: Central Office Building Unit Ventilator

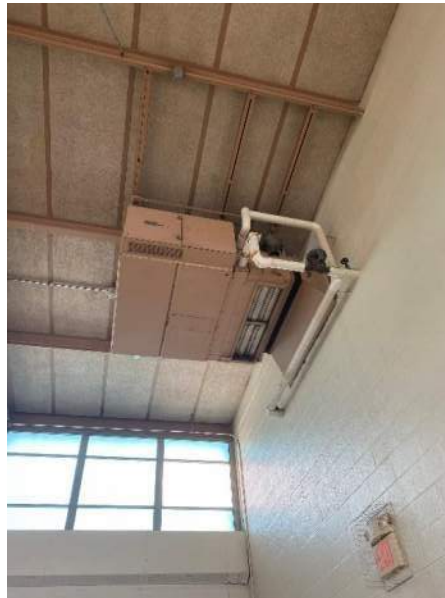
Typical Unit Ventilator serving gym

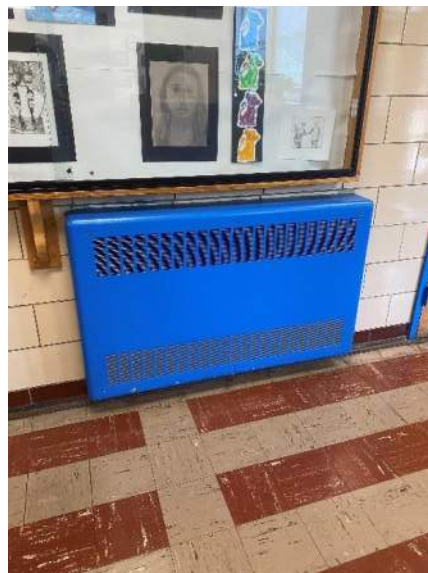
Typical hydronic radiator

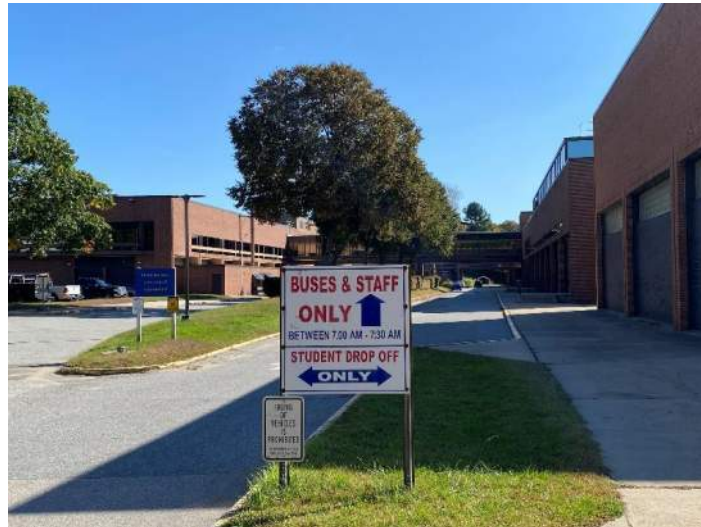
D.3.1: Main Entry

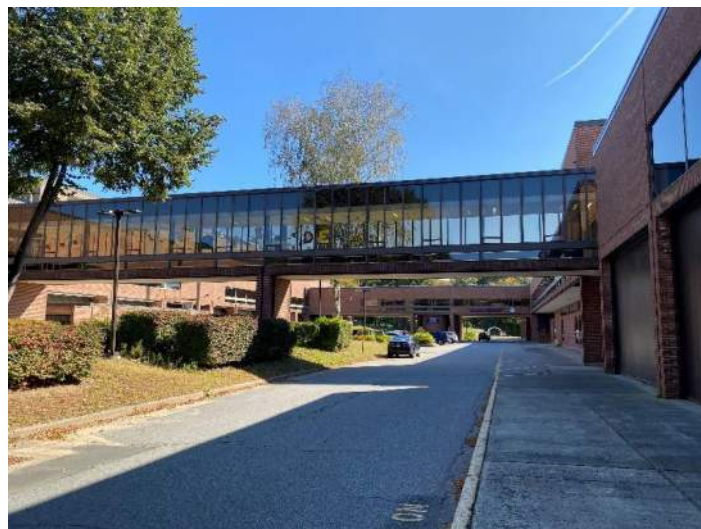
D.3.2: Entry Drive

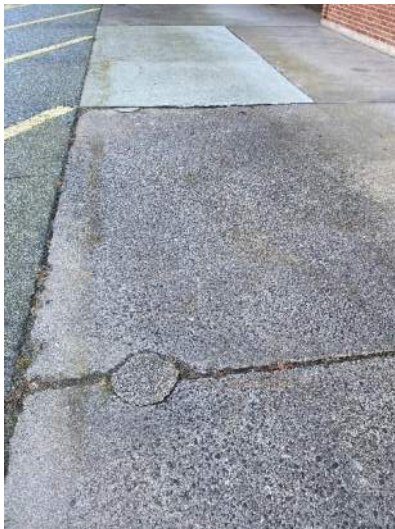
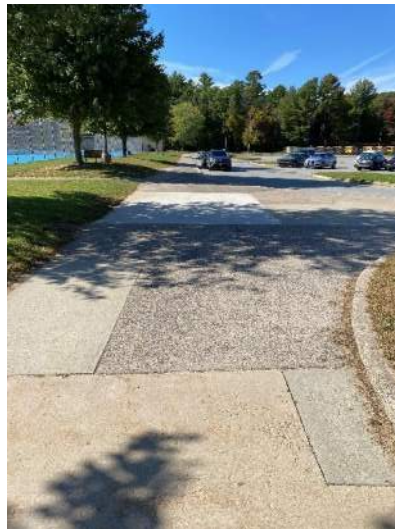
D.3.4: Walkways

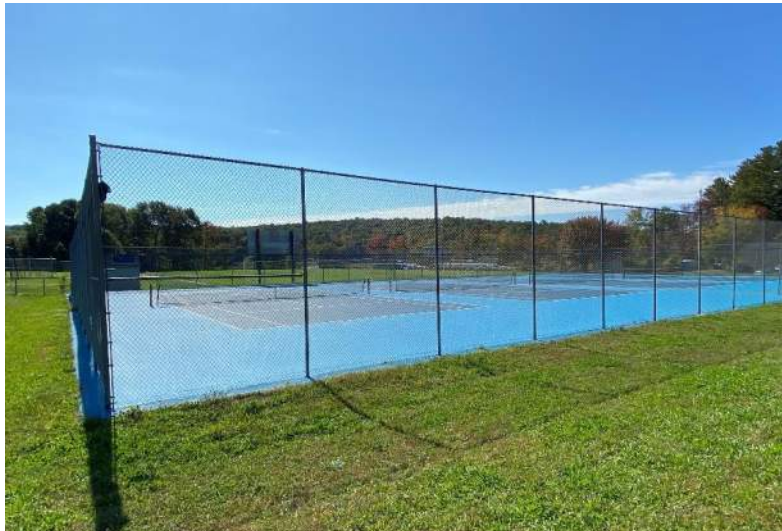
D.3.5: Tennis Courts

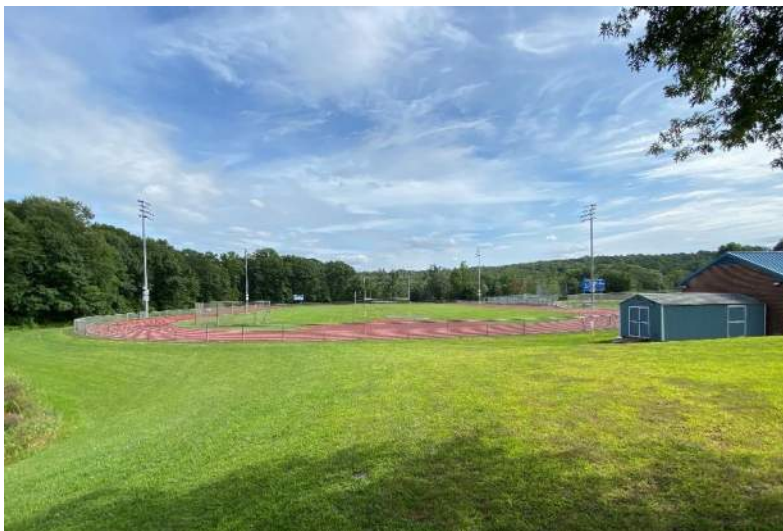
D.3.6: Track and Football Field

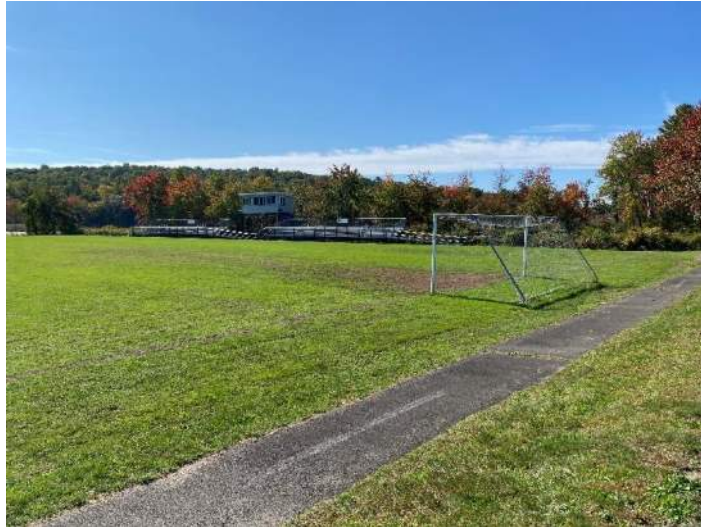
D.3.7: Soccer Field

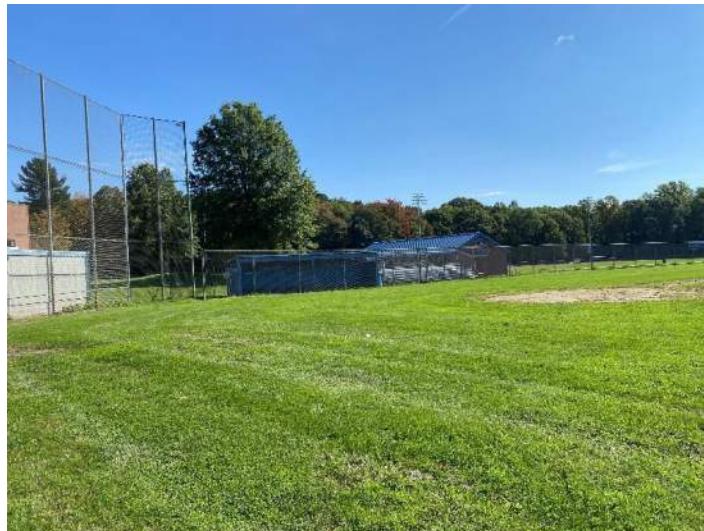
D.3.8: Diamond Fields

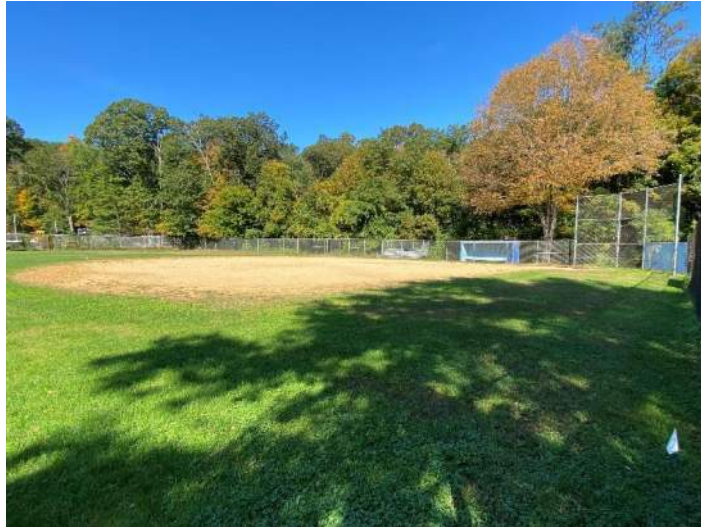
D.3.9: Diamond Fields

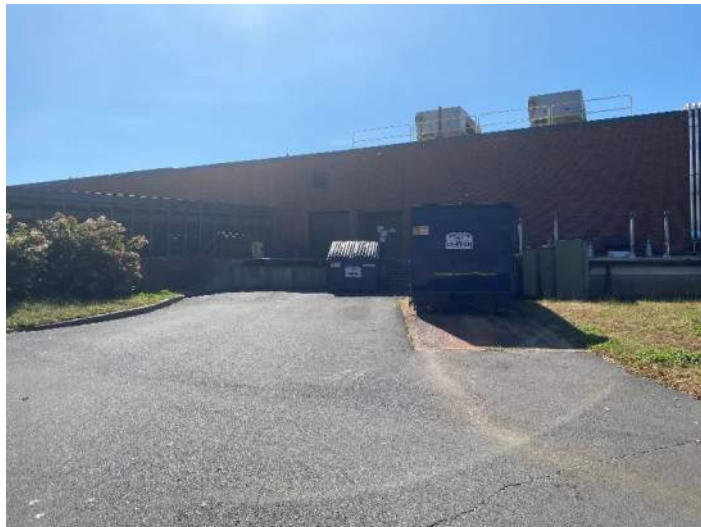
D.3.10: Loading Area
